# RESTORING A PROCESS PUMP FOLLOWING PREMATURE FAILURE

### Detailed inspection and overhaul return a critical asset to the required standard

AVTPUMP was asked by an existing customer to investigate a process pump that had failed shortly after being repaired by another provider.

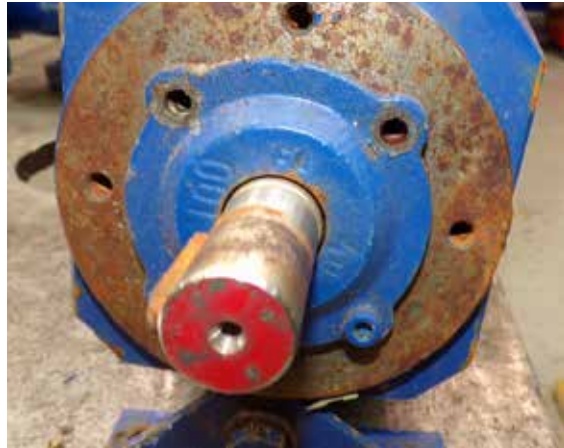
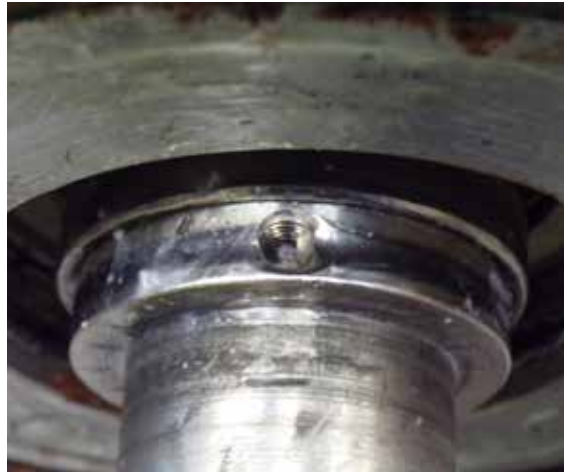
Inspection identified several serious issues with the earlier overhaul. Bolts were missing from bearing covers, the mechanical seal had been incorrectly set, and grub screws within the seal arrangement were either loose or absent.

Significant internal damage was evident throughout the pump, while dimensional checks confirmed that the bearing lands were oversized.

Parts that did not meet the required original specification had also been fitted, creating further concerns for an asset operating within an ATEX-regulated, top-tier COMAH environment.

AVTPUMP completed a full overhaul using correctly specified components and restored the pump to the required original dimensions and build standard.

The mechanical seal arrangement was correctly installed and set, all missing or unsuitable components were addressed, and the pump was rebuilt to provide a reliable and compliant repair.
