## URGENT REPAIR OF ELECTROLYTE TRANSFER PUMP

### Identifying abrasive sludge contamination as the root cause of efficiency loss

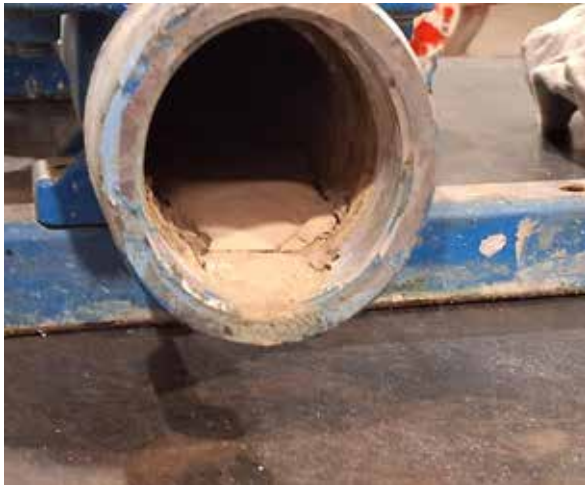
Inspection revealed a heavy build-up of highly abrasive sludge within the pump. This contamination had caused excessive wear to the wet end components, which directly explained the drop in pump efficiency.

Further investigation suggested that the main holding tank feeding the pumps had been allowed to run low. As sludge typically settles at the bottom of the tank, low tank levels allowed this material to enter the pump, causing rapid internal wear.

AVTPUMP completed a full repair using OEM spare parts.

The pump was fitted with new Santoprene diaphragms, stainless steel balls and valve seats.

All O-rings were replaced, and the air side was fully overhauled using an air kit.

Following repair, the pump was pressure tested and returned to site ready for service.

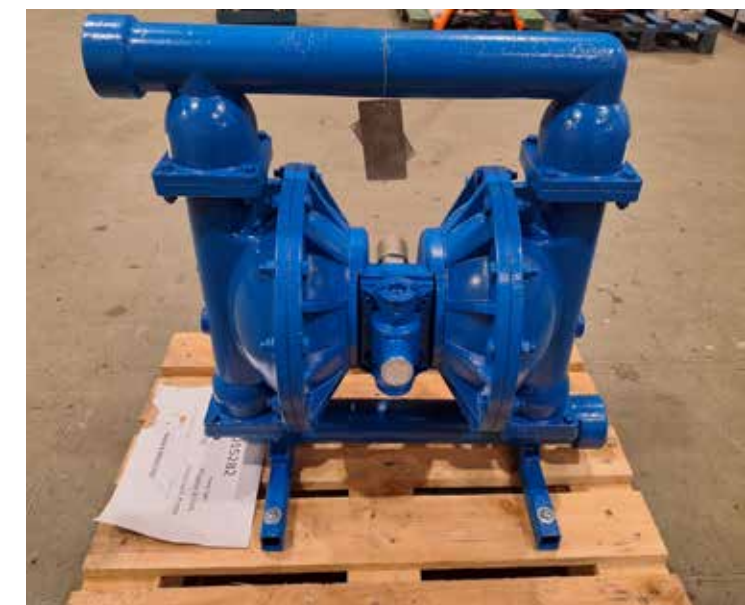
**Equipment:** Air-operated diaphragm pump

**Key Issue:** Abrasive sludge contamination causing wet end wear and efficiency loss

**Products Used:** OEM spare parts, Santoprene diaphragms, stainless steel balls and valve seats, O-rings, air kit
