# RAPID TURNAROUND OF CRITICAL MOLTEN SULPHUR PUMP

Improving availability through stocked spares,  
seal support and installation review

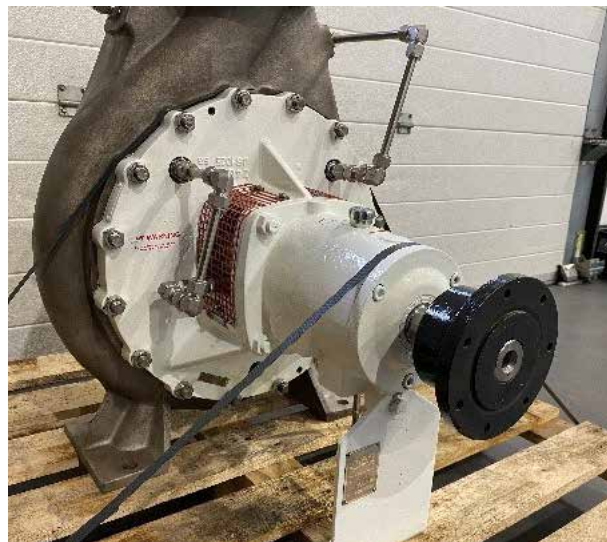
Inspection identified heavy contamination throughout the pump, along with water ingress in the bearing housing. Further investigation indicated that the moisture was likely condensate caused by the way the pump had been lagged.

The process media was also found to build up around the impeller and volute, impeding flow and contributing to performance issues. Due to the high temperature required for molten sulphur transfer, the mechanical seal required a steam flush to prevent solidified product building up inside the seal chamber and causing premature failure.

The existing seal flush arrangement was therefore reviewed and improved, with pipework upgraded to stainless steel using twin ferrule fittings.

Working with AESSEAL®, a bespoke mechanical seal solution was technically verified for the application, supported by an upgraded steam flush arrangement to improve reliability and reduce the risk of product solidification around the seal.
