# GEAR OIL PUMP OVERHAUL & BEARING UPGRADE

## Re-engineering obsolete components to improve future repair turnaround

AVTPUMP received a purchase order to collect and overhaul a critical gear oil pump from a manufacturing site.

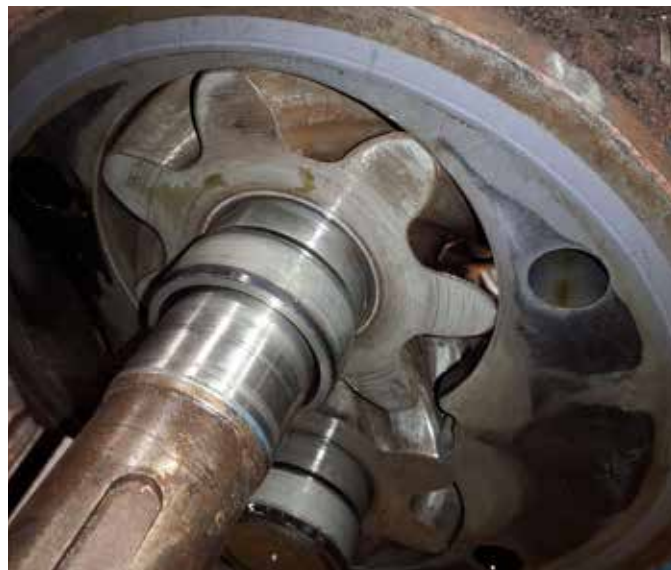
Inspection revealed significant wear across several critical components. Both pump shafts were worn at the lip seal and coupling locations, while the bearings and bearing housing locations had deteriorated beyond acceptable tolerances.

The original imperial roller bearings were replaced with modern metric cylindrical roller bearings. To accommodate the upgrade, all bearing housing locations were precision machined and re-bushed to suit the new bearing arrangement.

Both shafts were also machined to the new bearing diameters, while the lip seal arrangement was updated to suit modern metric seals. Following completion of the machining work, the pump was fully rebuilt, tested, and prepared for return to service.

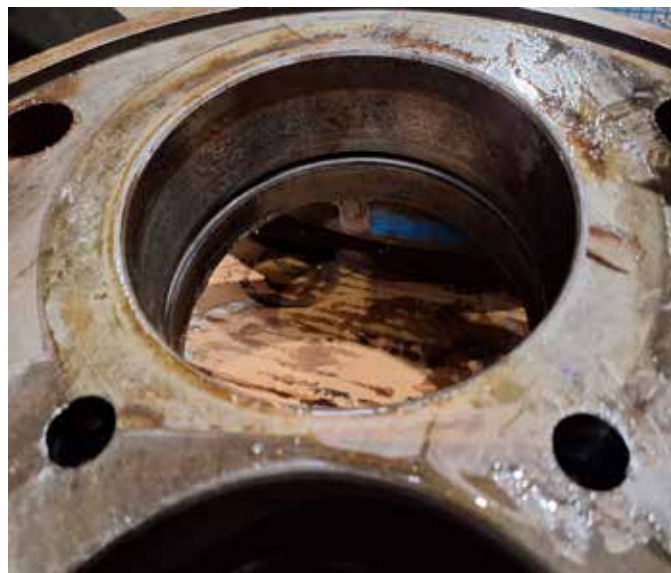
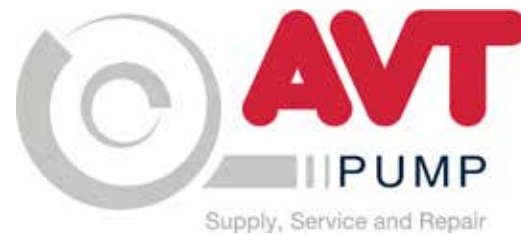
A further challenge was the use of obsolete imperial bearings, which had become increasingly difficult to source and posed a risk to future repair lead times.
