# Reducing Repeat Failures on a Critical Vertical Sump Pump

## Lubrication system modification improves reliability and reduces repair frequency

AVTPUMP was engaged by an existing customer to carry out the urgent overhaul of a vertical sump pump supplying water to a critical steel production process.

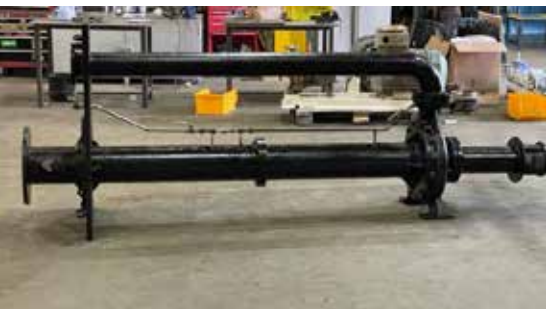
The pump was experiencing high motor current and repeated reliability issues linked to its cutlass bearing arrangement.

The existing bearing lubrication relied on process water being fed from the pump volute through a dedicated pipe. Scale ingress had blocked this route, preventing lubrication from reaching the bearings.

As a result, the bearings began to run dry, causing significant wear, shaft contact and near seizure of the pump. This increased the load on the motor, leading to high current draw and repeated tripping.

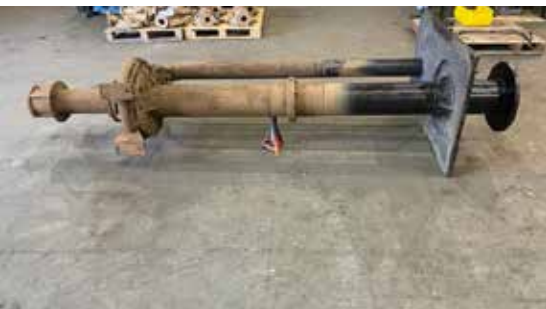
Inspection identified severe wear to the cutlass bearings, with scale contamination preventing the required lubricating flow.

The resulting dry running had caused the bearings to pick up on the shaft and brought the pump close to seizure. This explained the high motor current and operational trips reported on site.

AVTPUMP completed a full overhaul, including the installation of a new shaft, shaft sleeves and bearings.

The lubrication pipework was then modified to include an independent external water connection from the top of the pump frame. This allowed a clean mains water supply to be introduced directly to the bearings while the pump was operating, removing reliance on the scale-prone process-water feed.

New pipework and valves were installed to support the revised arrangement before the pump was rebuilt and returned to site.
