# RESTORING A PROCESS PUMP FOLLOWING PREMATURE FAILURE

### Detailed inspection and overhaul return a critical asset to the required standard

AVTPUMP was asked by an existing customer to investigate a process pump that had failed shortly after being repaired by another provider.

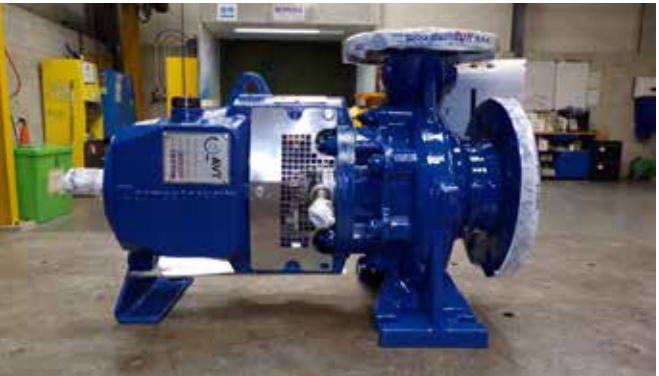
Inspection identified several serious issues with the earlier overhaul. Bolts were missing from bearing covers, the mechanical seal had been incorrectly set, and grub screws within the seal arrangement were either loose or absent.

Significant internal damage was evident throughout the pump, while dimensional checks confirmed that the bearing lands were oversized.

The mechanical seal arrangement was correctly installed and set, all missing or unsuitable components were addressed, and the pump was rebuilt to provide a reliable and compliant repair.
