## EXTENDING THE LIFE OF CRITICAL FIRE PROTECTION INFRASTRUCTURE

### SERVICE MATTERS

EQUIPMENT: 8/10 split case fire pump

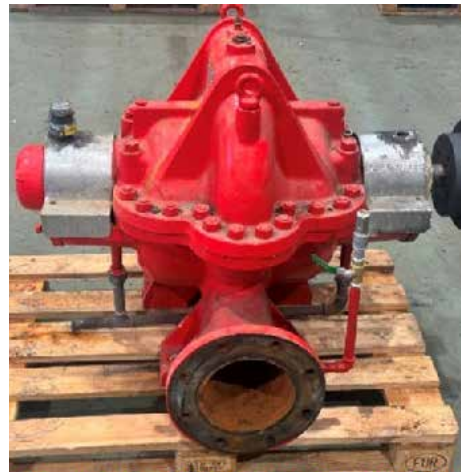
BEFORE

Due to the age of the pump, original OEM spares were no longer available. Key components including the pump shaft, casing wear rings, shaft sleeves, and bushes required reverse engineering and manufacture to restore the pump to its original performance and reliability.

The pump design dated back to the 1960s, meaning tight tolerances and precise machining were essential to ensure correct clearances and long-term serviceability.

AVTPUMP engineers removed the pump from site and returned it to our Gloucester workshop for a full strip-down, inspection, and dimensional assessment.

All critical wear components were reverse engineered and manufactured in-house, including a new pump shaft, casing wear rings, shaft sleeves, and disaster bushes. The free-issued impeller was precision machined before assembly.

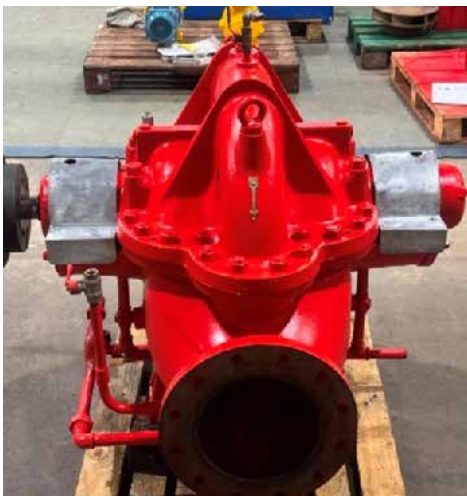
AFTER

Despite the age of the equipment, all internal clearances and tolerances were returned to the original manufacturer's specification, extending the operational life of the pump and avoiding the need for full replacement.

Once rebuilt, the complete rotating assembly was dynamically balanced to G2.5 standard to minimise vibration and extend bearing and seal life. The pump was then pressure tested and performance tested to verify hydraulic performance and confirm compliance with original design specifications.

Following workshop testing, AVTPUMP engineers reinstalled the pump on site, carried out laser alignment, and completed full commissioning to return the asset safely to service.
