## IMPROVING RELIABILITY OF FRYER CIRCULATION PUMPS

### Reducing Repeat Failures Through Repair Quality and Process Insight

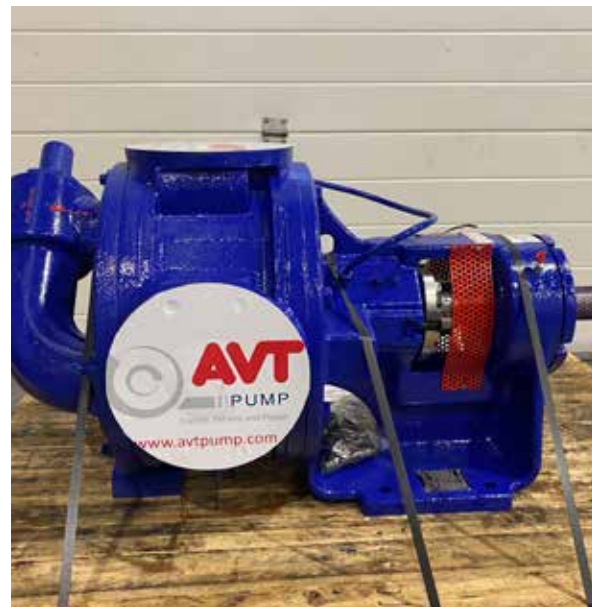
Inspection confirmed that fine particulate contamination within the hot oil was entering the pumps and causing accelerated wear.

Bushes and bearings were subject to premature degradation, and the presence of contamination increased the likelihood of seizure. Mechanical seals were also affected, reducing overall reliability and increasing the frequency of intervention.

AVTPUMP carried out full overhauls of the affected pumps, including replacement of worn bushes, bearings, and mechanical seals to restore correct operation. Repair standards were aligned to ensure consistency across all units, improving reliability and extending service life between interventions.

In parallel, recommendations were made to address the root cause of failure. This included the removal or reduction of particulate contamination before it enters the pumps, as well as the implementation of proven bedplate modifications previously applied at another site to improve stability and repeatability.
